AN EVALUATION OF EXPERIMENTAL
REHABILITATION WORK,
REDWOOD NATIONAL PARK

TECHNICAL REPORT
JULY 1987

Redwood National Park Watershed Rehabilitation
Technical Report Number 19

National Park Service
Redwood National Park
Arcata, California
July 1987

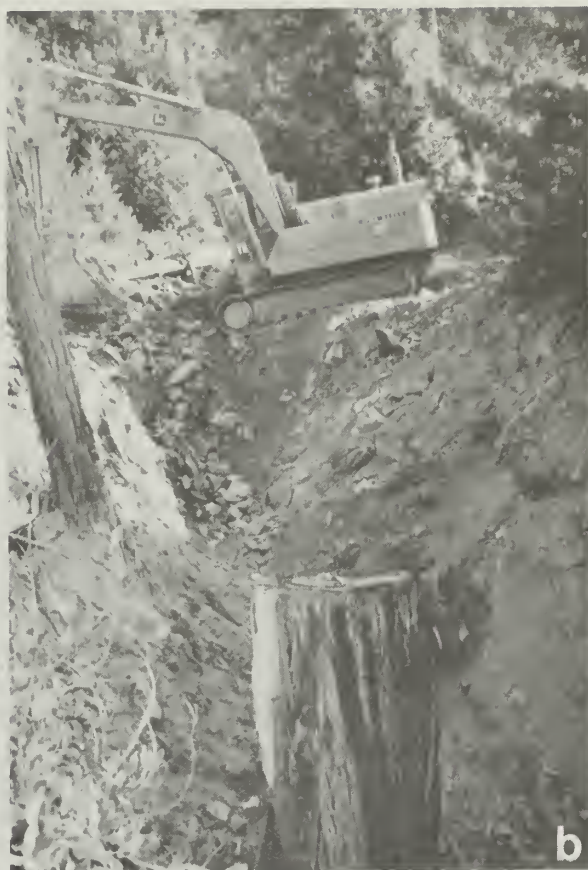
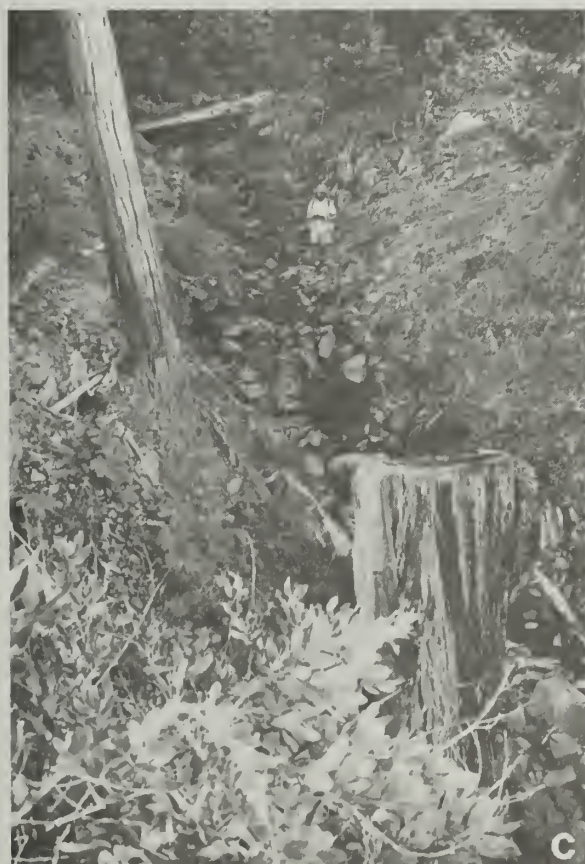
Fig. 66. Excavation of logging road stream crossings using a hydraulic excavator. A) initial excavation of the outboard edge of the crossing is done while the excavator sits on the road surface; B) as the former bed and banks of the stream channel are exhumed or reconstructed, the excavator moves to one side and passes material onto the road surface directly behind it; C) same crossing after approximately four years, note minor channel adjustment and the lag deposit of coarse rock armor which has developed in the streambed.

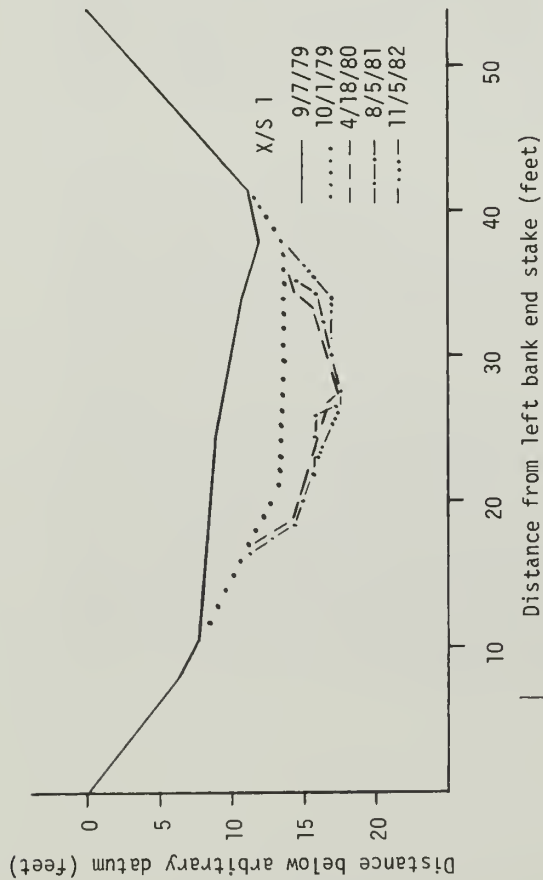
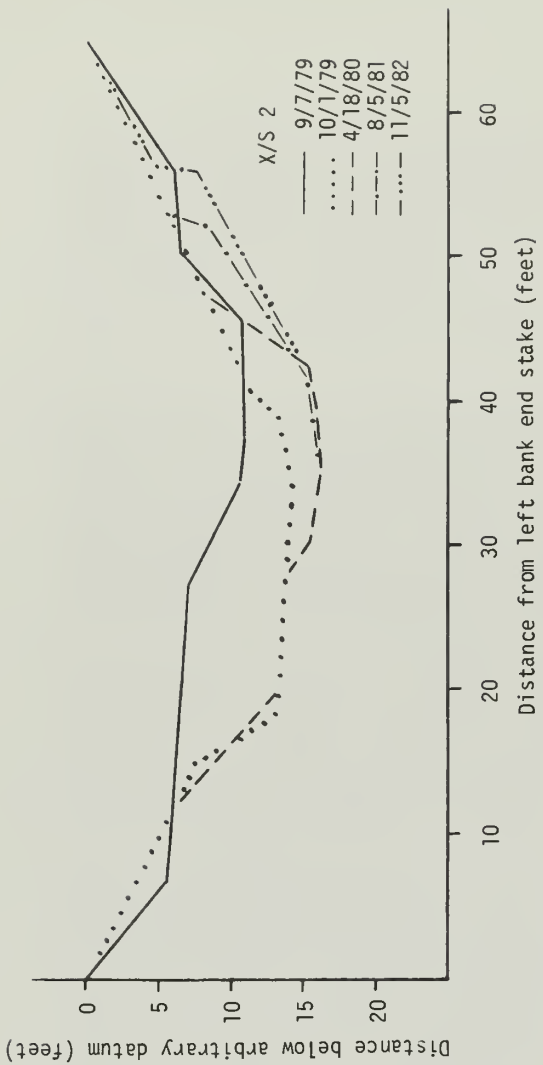
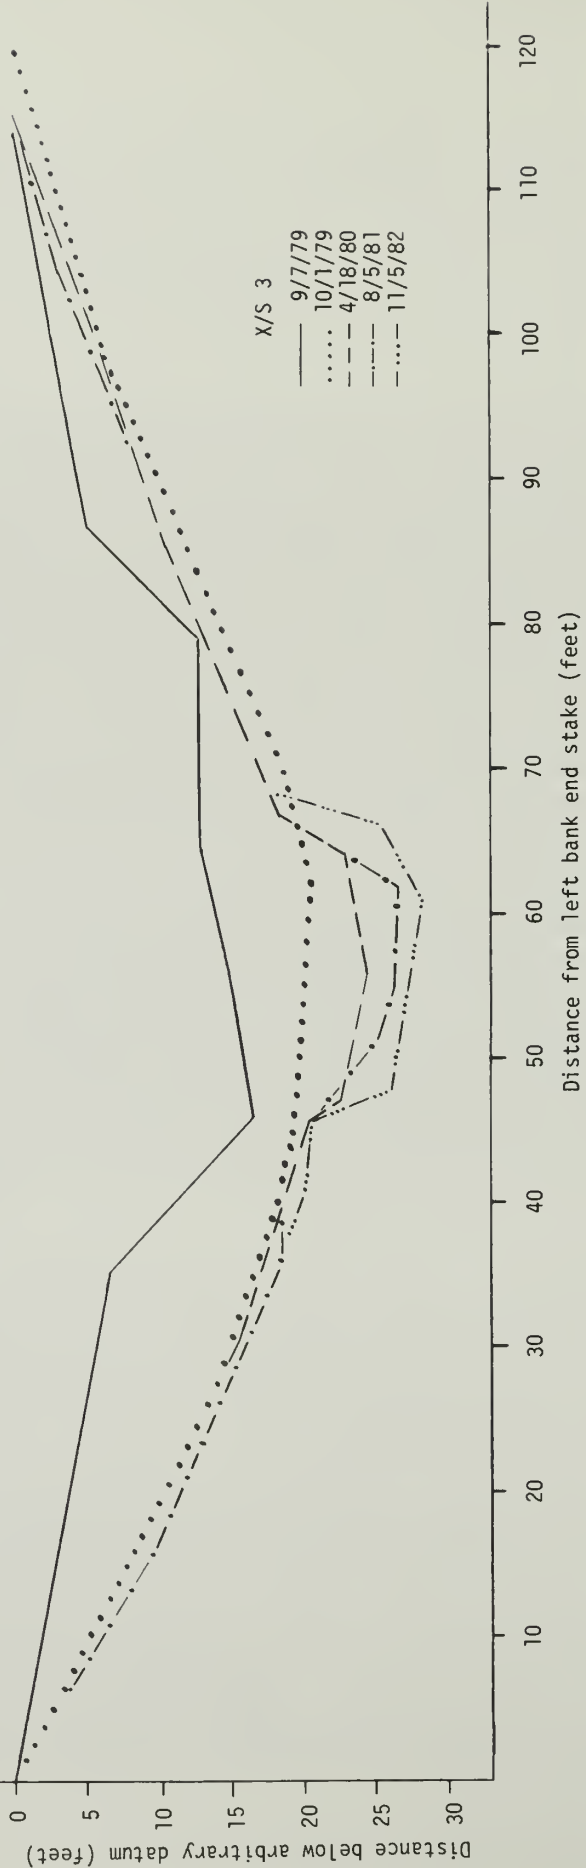
Fig. 67. Six channel cross-sections of Copper Creek at the site of the excavated log jam. Cross-sections were measured prior to log jam removal (September 1979), immediately following heavy equipment operations (October 1979) and once during each of the following three years (April 1980, August 1981, November 1982).

As a result of the 1980 winter storms, an additional 560 cubic yards were eroded from the site. Most of the bedload loss was associated with channel scour from increased flow velocities on the unprotected loose sediment within the excavated stream reach. During the following winter (1981) an additional 60 cubic yards were eroded (Figure 69). Most of this occurred near cross-sections 2 and 3 where an average of 2 - 4 feet of bank erosion was detected (Figure 67).

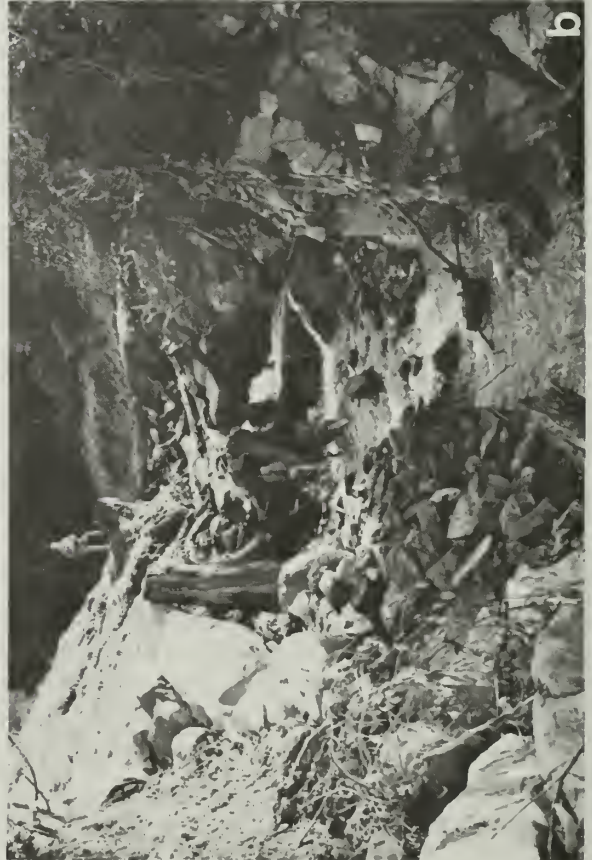
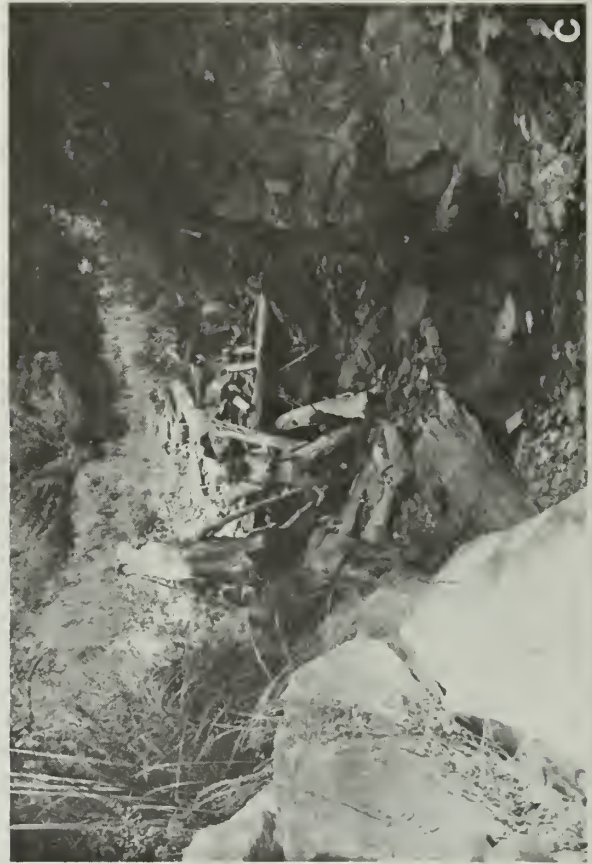
The change in erosional mechanisms from channel downcutting to channel widening was predictable. By 1982, in-place, stream-bed boulders were being exhumed throughout much of the log jam reach (Figure 70). The increase in particle size (roughness) coincided with the exposure of stumps whose basal flair indicated the stream channel was nearing its original grade. With the exception of the upstream migration of a few knick points in the channel profile (Figures 68 and 69), the dominant response to increased discharge was channel widening (Figure 67). The excavated, unstable hillslopes along the right bank (Figure 58) remained intact through November 1982. The primary objective of stabilizing the adjacent hillslopes through removal of the log jam was attained. Total cost for log jam removal including riprapping, was \$10,250, averaging \$6.00 per cubic yard of material excavated.

Fig. 70. Exhumed cobbles and boulders in the treated reach between the middle and upper log jam steps, Copper Creek. Within the first two years following channel clearance, the stream had downcut and widened several feet and exposed stable boulders in the bed of the original channel.

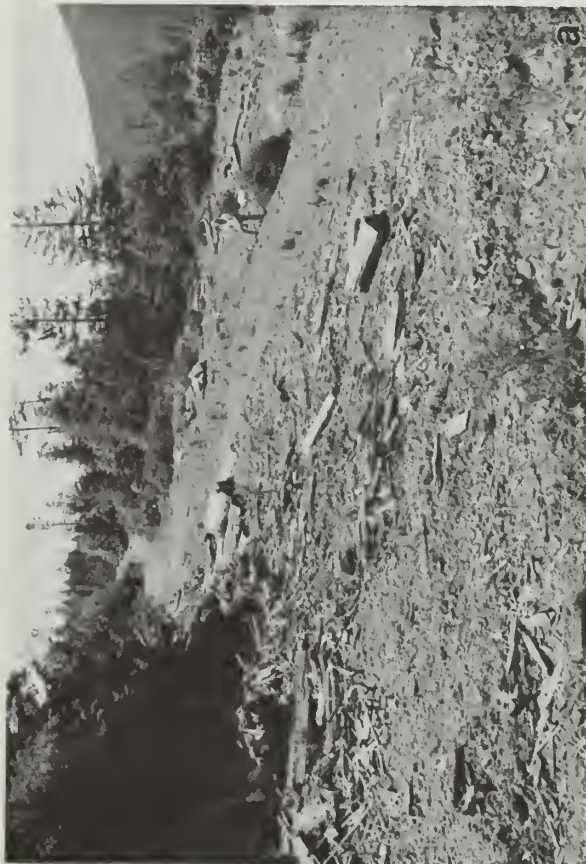
Ripping roads as the last step during rehabilitation appeared to have enhanced natural seeding and revegetation efforts at Copper Creek (Figure 71). Ripping at this late stage appeared more effective than similar disaggregation practices done at the beginning of heavy equipment operations, when recompaction occurred. However, given the

Fig. 71. Natural revegetation of a decompacked road surface. A) before rehabilitation, the former road surface showed little natural revegetation in the 10 years following its abandonment; B) same area immediately following decompack and outslipping (November 1979); C) four years later (September 1983) the site has been covered with naturally invading coyote brush. Revegetation of this hot, dry southwest facing slope contrasts sharply with the cool moist areas in Bridge Creek (unit 79-2) which were invaded by rapidly growing alder.

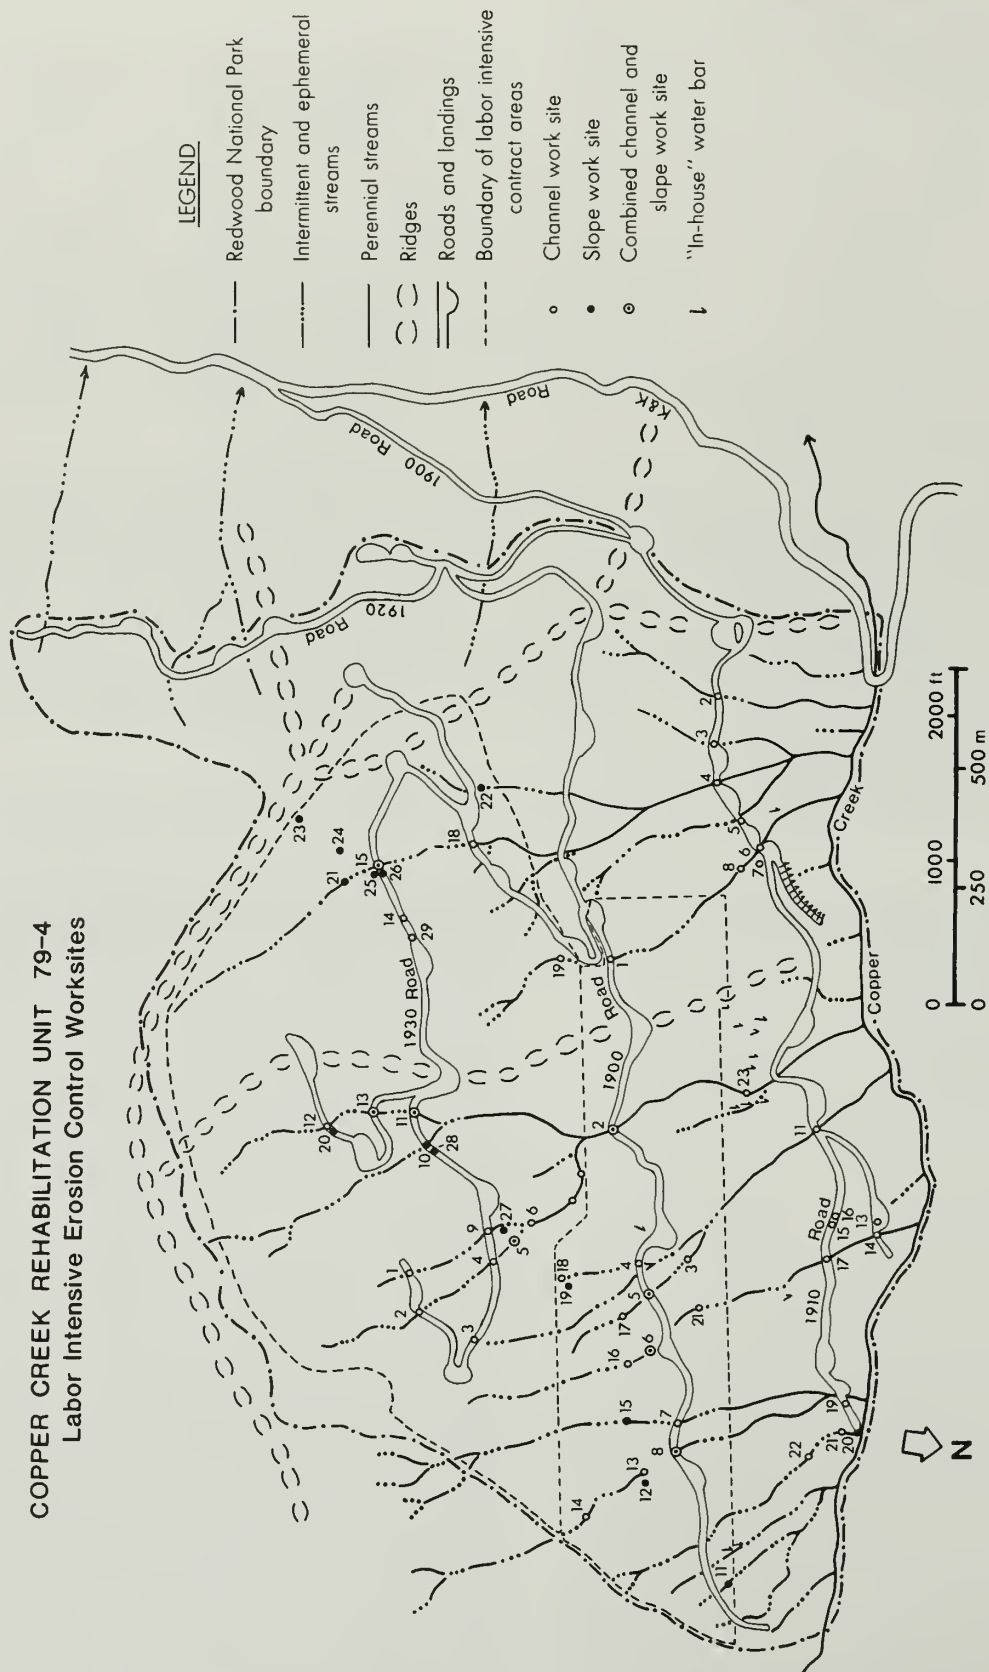
COPPER CREEK REHABILITATION UNIT 79-4
Labor Intensive Erosion Control Worksites

Fig. 72. Labor intensive erosion control work sites on the Copper Creek rehabilitation unit. Note the dashed lines which delineate the upper, middle and lower contract areas.

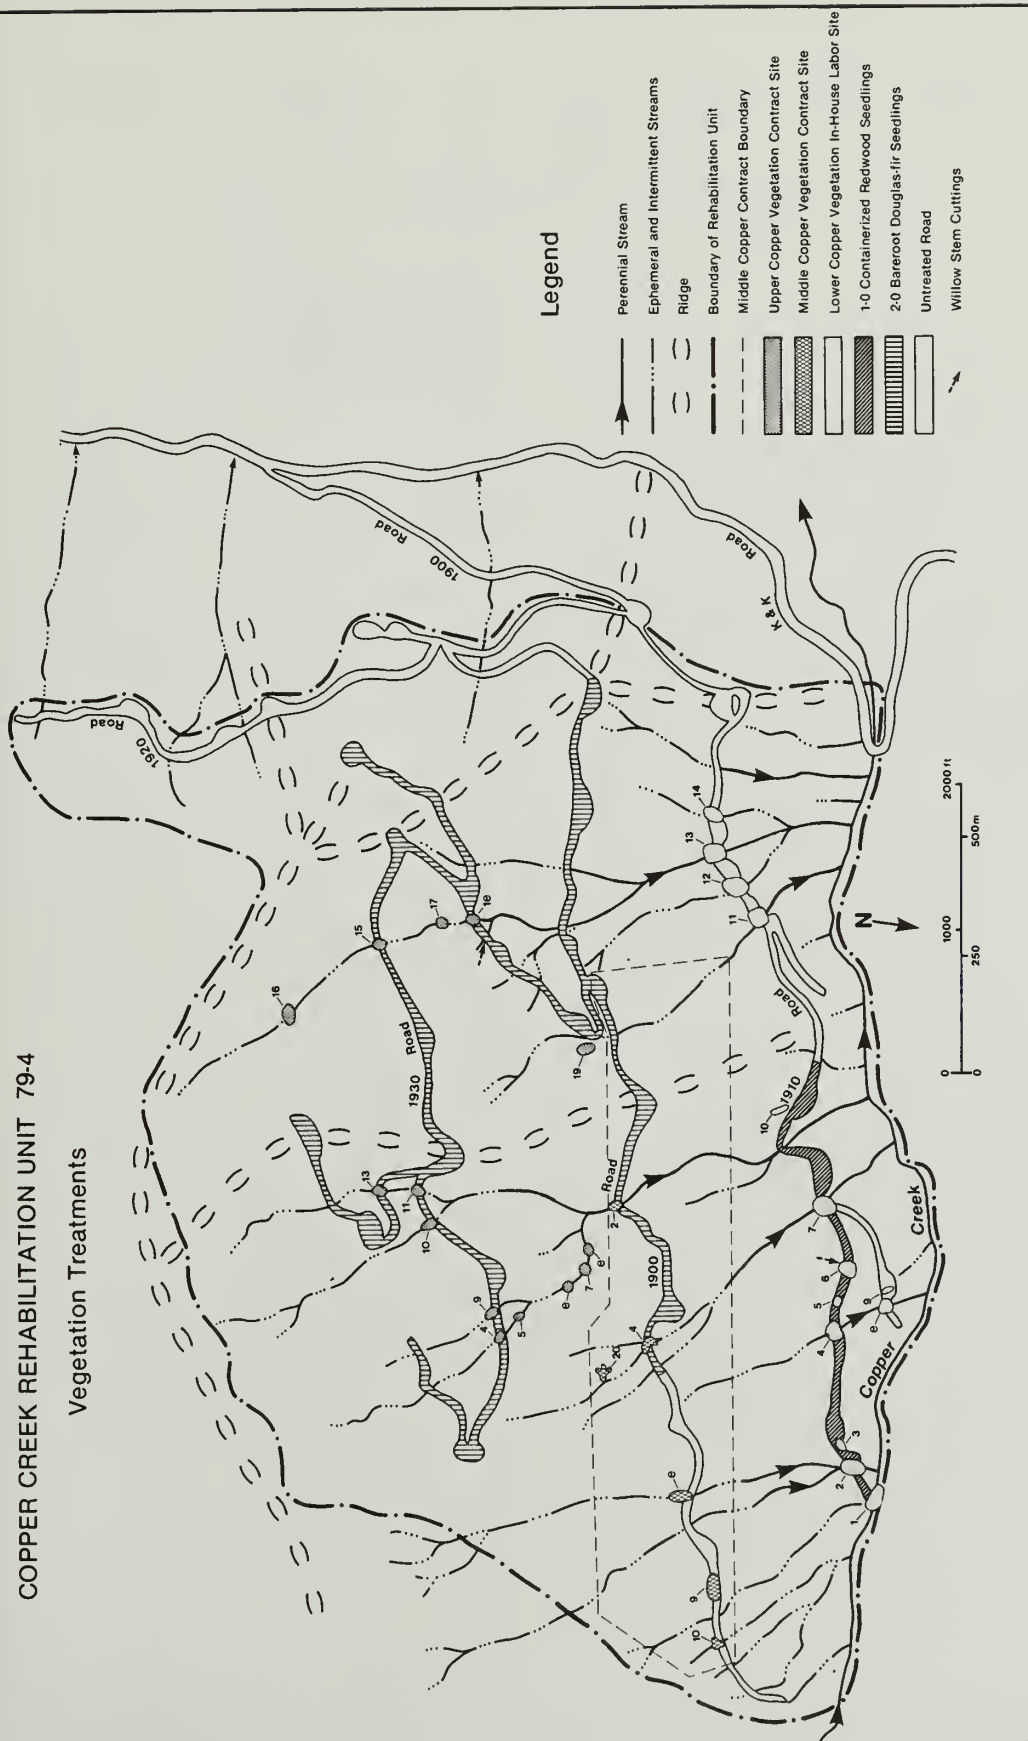
COPPER CREEK REHABILITATION UNIT 79-4 Vegetation Treatments

Fig. 73. Vegetation treatments on the Copper Creek rehabilitation unit.

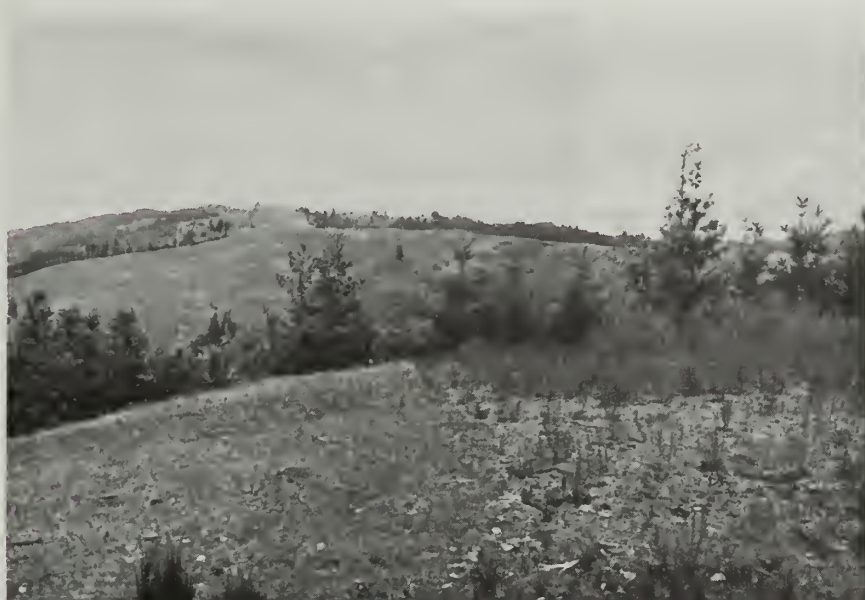
Where the RNP mix was seeded and fertilized, grass persisted with sufficient cover (>60 percent) to exclude significant natural invasion (Figure 81). Coyote brush, the main woody colonizer, was relatively sparse on areas seeded with the RNP mix but abundant in unseeded areas and areas seeded with barley. The areas seeded with barley were nearly indistinguishable from untreated areas.

Fig. 81. Shrub invasion in unseeded (right) and grass seeded areas (left) on treated landing in Copper Creek. Competition with grass on the left half of the landing totally inhibited natural invasion of coyote brush and other shrubs.

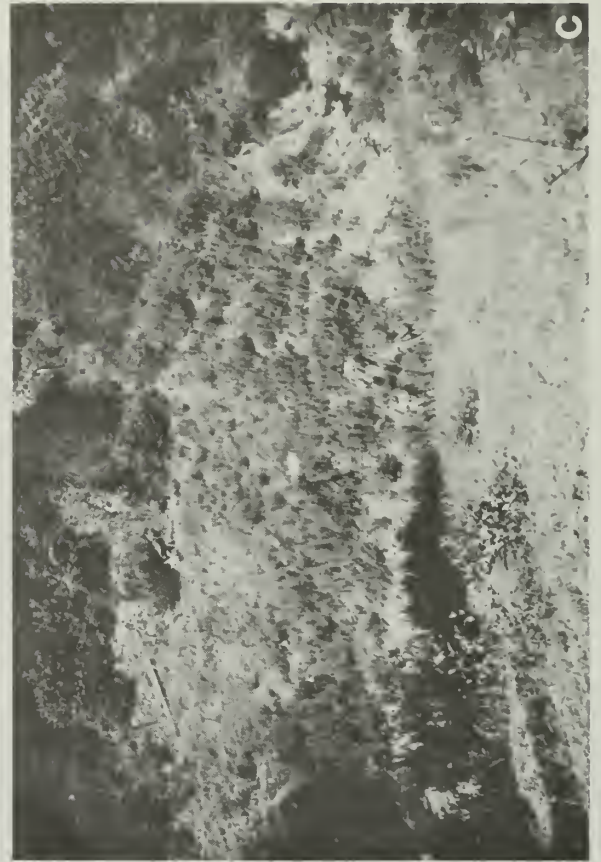
The most widely used mulch was straw. Average straw cover the first year was 90 percent, but declined to <5 percent by the third year. Heavy natural invasion by coyote brush and herbaceous species was seen on many unseeded, strawed areas (Figure 82). Several areas mulched with

Fig. 82. Natural revegetation of excavated stream crossing with straw mulched side slopes, Copper Creek. A) Partially washed out stream crossing displays unstable banks and minimal natural revegetation eight years following road abandonment (July 1979); B) several months after excavation of fill (December 1979) showing straw mulch and rilling on side slope following first winter rains; C) four years after rehabilitation (September 1983), note abundant natural invasion of coyote brush on right bank.

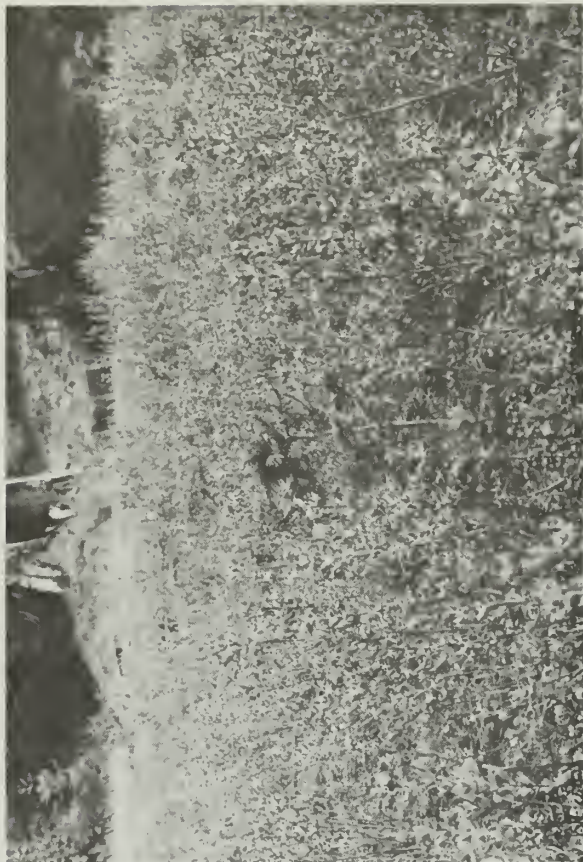
Observation of conifer seedling survival indicates species, initial size, and substrate affect the trees' health. By 1983, survival of redwood seedlings planted on the lower road was low (approximately 20 percent). Many of those surviving seedlings were stressed, but may become better established as alders shade more of the road. Observations of plantings in succeeding years indicated that two-year old bareroot stock (both redwood and Douglas-fir) have higher survival and growth rates than one-year old containerized stock. For this reason, and because the two-year stock are no more expensive than the one-year old contained seedlings, they are now preferred (Figure 83).

Fig. 83. Two-year old bareroot Douglas-fir and one-year containerized redwood seedlings were planted at Copper Creek.

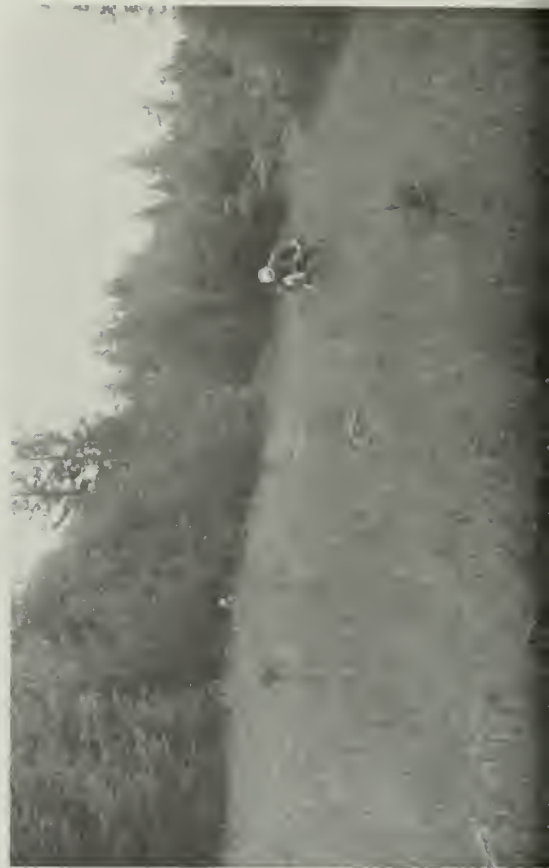
Fig. 85. Competition from grass in heavily seeded areas lowered survival and reduced vigor of outplanted conifers. Concentrations of grass also attracted elk and deer which then browsed on the planted trees.

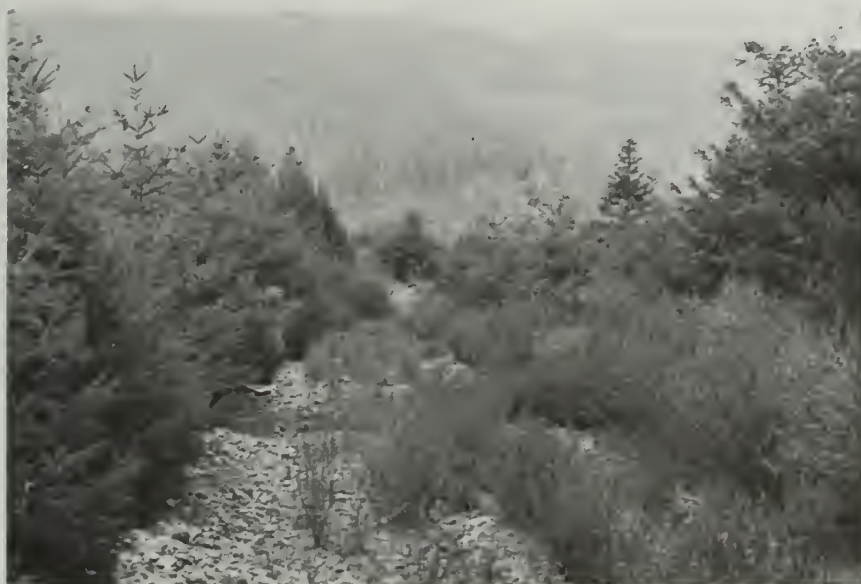
Fig. 86. Natural invasion of coyote brush. Unlike the Bond and Bridge Creek units, where alder was the principal early colonizer, the hot, dry, rocky skid trail and road surfaces of Copper Creek were quickly invaded by coyote brush.
